MATERIALS DETERIORATION IN TROPIC VERSUS CONUS SITES

FREDDY/CHEN! Ph.D. US ARMY TROPIC TEST CENTER APO Miami 34004

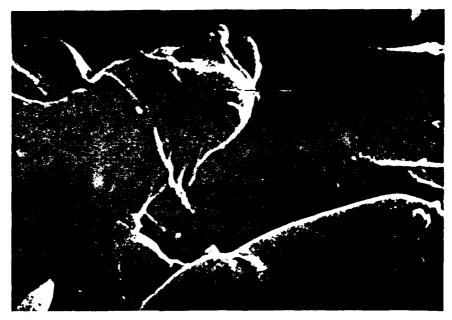
Environmental degradation occurs most readily on the surface of the POL tank fabric. Therefore, a scanning electron microscope was used to determine the various results in surface deterioration. Figure 8 shows severe deterioration of POL tank fabric exposed for 2 weeks at Key West, a coastal site. Some sections of this fabric had deep cracks. The same result of cracking occured, but not severely, on fabrics exposed at McKenzie Forest in Panama (figure 9). The McKenzie Forest sample also contained fungal activity with a collection of debris and salts. The deterioration process was different for fabrics exposed at Quinault; the fabric did not crack but curled. Figure 10 shows a POL tank fabric that had been exposed at Quinault for 7 months.

Figure 10. Photomicrograph of Deterioration to Surface of POL Tank Fabric Exposed at Quinault for 7 Months, 1000X.

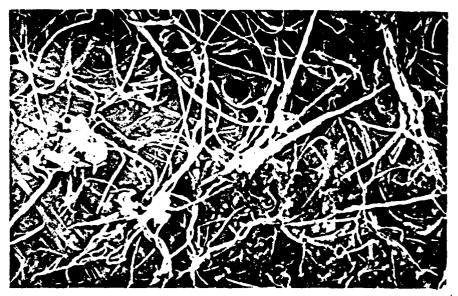
One main difference between exposure at Key West and its counterpart in Panama--Fort Sherman Coastal--was fungal activity. Cellulose acetate samples exposed for 2 weeks in Key West did not show evidence of fungal attack, but did exhibit surface deterioration (figure 11). However, samples exposed for 2 weeks at the Fort Sherman Coastal site were covered with fungal mycelia, debris and salts (figure 12).

Figure 12. Photomicrograph of Deterioration to Surface of Cellulose Acetate Exposed at Fort Sherman Coastal Site for 2 Weeks, 520%.

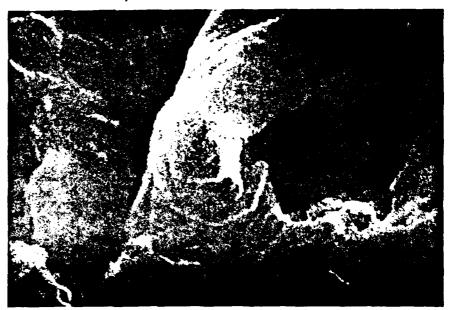
Fungal attack occurred either by a suction process as shown in figure 16, or by surface penetration as shown in figure 17. Figure 16 shows the deterioration of latex after being exposed for 4 months in Quinault. Figure 17 shows the deterioration of mylar after being exposed for 7 weeks at McKenzie Forest. Salt also can penetrate surfaces (figures 18 and 19) as shown on the mylar samples exposed at the Fort Sherman Open Exposure Site for 2 weeks (figure 18). The cellulose acetate sample (figure 19) exposed for 12 weeks at Key West showed severe surface salt penetration.

Figure 16. Photomicrograph of Fungi on Surface of Latex Exposed at Quinault for 4 Months, 1000X.

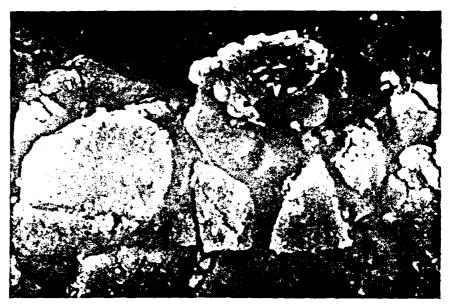
Another cause of surface deterioration is stress relaxation. A good example is shown in figure 20. The latex sample was exposed at the Quinault site for 7 months. After 7 months, a partial coalescence of surface particles had occurred. Stress relaxation from surface coalescence caused the surface fibers to pull apart. Surface deterioration at this site was so slow that the process was observed and analyzed easily. At sites with surface deterioration occurring rapidly, it was difficult to capture and analyze the deterioration process. High solar radiation levels found at the Fort Sherman Coastal Exposure Site caused surface deterioration to occur rapidly. Severe surface destruction occurred on latex samples exposed at this site for 2 weeks (figure 21).

Figure 21. Photomicrograph of Surface Deterioration to Latex Exposed at Ft Sherman Coastal Site for 2 Weeks, 378X.
